Manhole Inspection Summary

Manhole # S47MM_037MH

Location Address: **Patteson Park Ave**

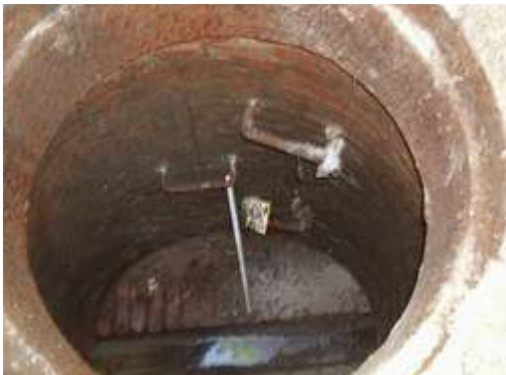
Defect 1

Frame Offset: **0** (in.) Condition: ☐ Sound ☐ Cracked ☒ **Leaks**

Frame leaks

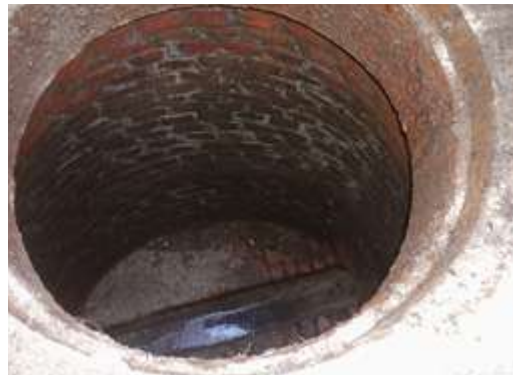
Defect 2

Infiltration: ☐ None ☐ Joint ☐ Cracks ☐ Mortar ☐ Roots ☒ **Wall**

Infiltration

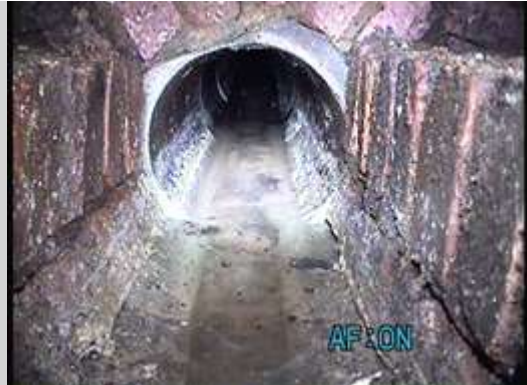
12 O'Clock Outflow

8 in. Circular Gravity Sewer
Pipe Out @ 12 O'Clock

Pipe Height: **8.4** (in.) Rod and Bar (Angled)
Pipe Material: **Clay** ☐ Pipe Lined
Invert Depth: **7.60** (ft.) Flow Characteristics: **None**
Deposits: ☒ None ☐ Mud ☐ Sludge ☐ Debris ☐ Grease
Silt Depth: (in.) Deposits Extent:
Infiltration: **None** Pipe Seal Cond: **Sound**

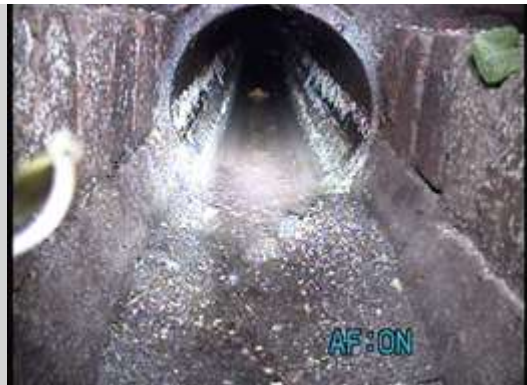
6 O'Clock Inflow

8 in. Circular Gravity Sewer
Pipe In @ 6 O'Clock

Pipe Height: **8.4** (in.) Rod and Bar (Angled)
Pipe Material: **Clay** ☐ Pipe Lined
Invert Depth: **7.55** (ft.) Flow Characteristics: **None**
Deposits: ☒ None ☐ Mud ☐ Sludge ☐ Debris ☐ Grease
Silt Depth: (in.) Deposits Extent:
Infiltration: **None** Pipe Seal Cond: **Sound**
